## Erosion Trend Analysis of Coastline along Ponnani Region Using Multitemporal Images

P. S. Sheeja<sup>1\*</sup>, B. Vishnu<sup>2</sup> and A. J. Ajay Gokul<sup>2</sup>

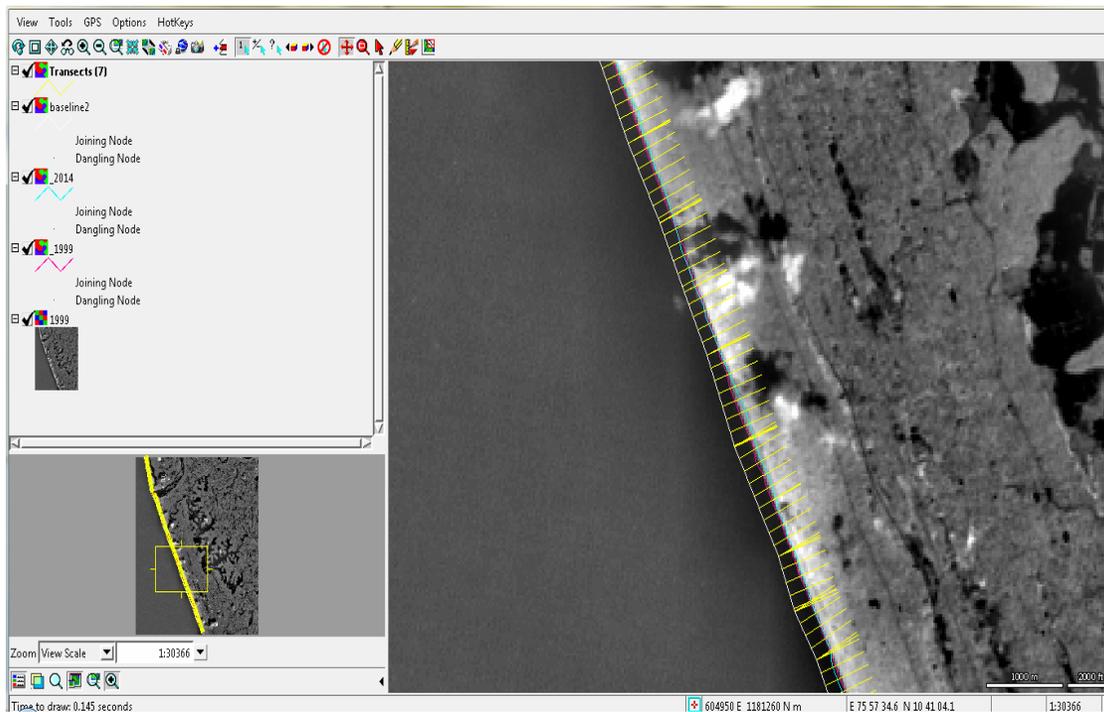
Figure.2 Erosion assessment by creating transects

An SML script that generates transects, or lines orthogonal to a shore baseline, has been developed for use with TNT products. A baseline and at least two subsequent shoreline measurements are all that is required to produce transects (lines orthogonal to the baseline) with associated erosion rates. The erosion rate along each transect is provided as a DataTip over the transect.
