Efficacy of Base Condition on Pump Performance

R.N. Shrivastava*, M.K. Awasthi and R.K. Nema

Department of Soil and Water Engineering, College of Agricultural Engineering,
JNKVV Jabalpur, India

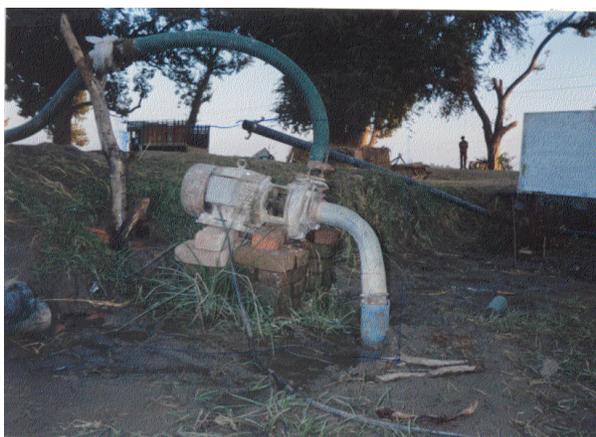
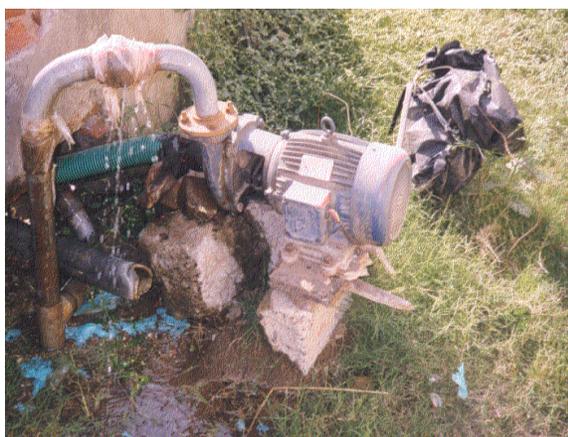
It is clearly depicted from the table 1 that 84% pump-sets are having poor foundation. Actually the improper selection of pumps, poor foundation and poor maintenance are the factors, which can be controlled with little awareness and attention. Farmers have no consideration for foundation. They just put the unit and run it as depicted from the pictures given below.
